PROJECT PERFORMANCE ASSESSMENT REPORT

JAMAICA

Hurricane Dean Emergency Recovery Loan

Report No. 153672

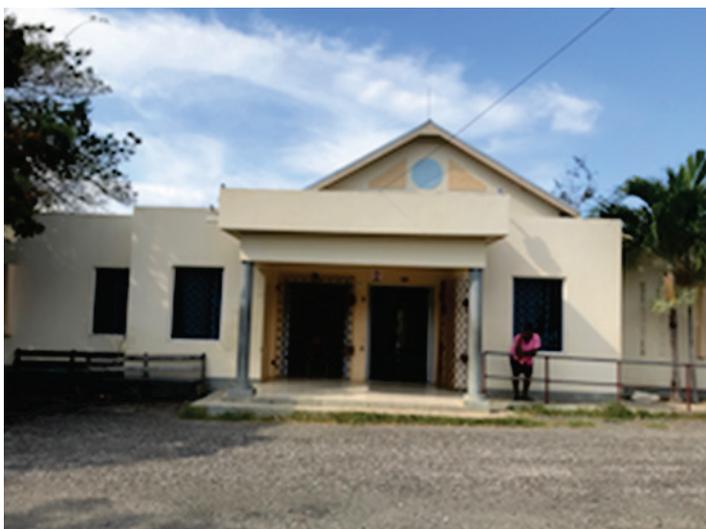
Photo B.1. Flanker Health Center

- In some clinics, waiting areas are smaller than before.
- Minor termite problems are common across facilities, especially the ones with more wood.
- Some cracks in the paint are noticeable.
- Minor water leakages occur with heavy rain.
- For some clinics, there is a lack of air conditioners and no electricity generators (no backup systems). The parish has some and provides the clinic with them in times of need.

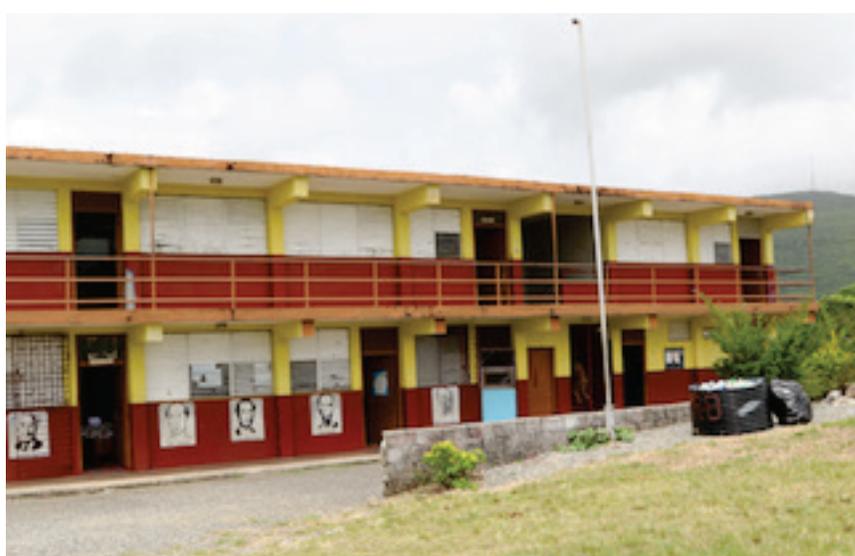
Photo B.2. Rowlandsfield All Age School

- Improvements in windows were funded across facilities. This stopped leaking during rain.
- Bars in windows were installed. Teachers expressed a sense of safety. Incidents of theft are now minimized (before the intervention, they used to be very common in at least two schools).

- Schools have never been since closed because of the effects of a natural event. Although some leaking occurs, the new buildings are able to withstand weather shocks.

- There is a lot of leaking when it rains. The leaking is not disruptive enough to prevent classes, but teachers must clean and move children from one classroom to another. This problem was present shortly after project completion.
 - Wear-off of paint was evident. Staff members expressed that there are not resources to repaint.
-

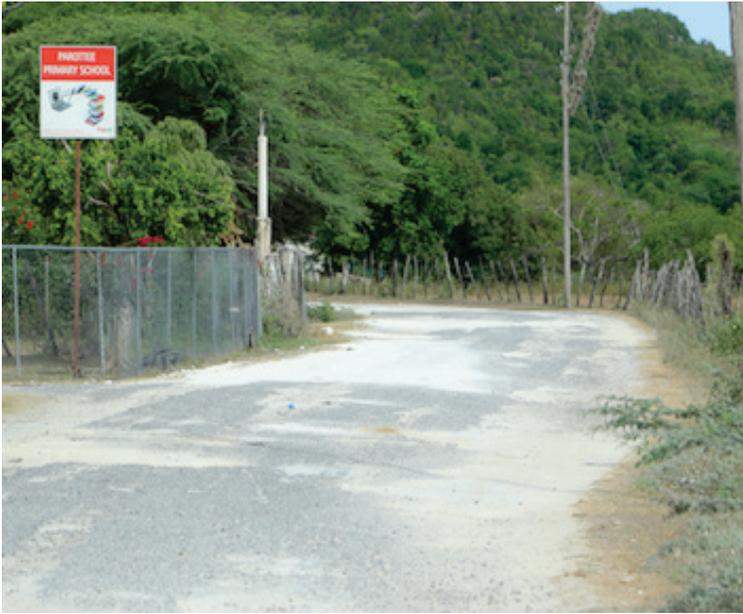
Photo B.3. Parottee Road

Feeder roads are in good condition (with the exception of Green Field Road). Listed below are the general findings from the site inspections:

- Surfaces are in good condition, except for minor asphalt deterioration.
 - Generally, drains are clean and functional.
 - Vegetation needs attention. Some mobility problems are present owing to the abundance of plants. There is a risk of vegetation falling into the drains.
-
